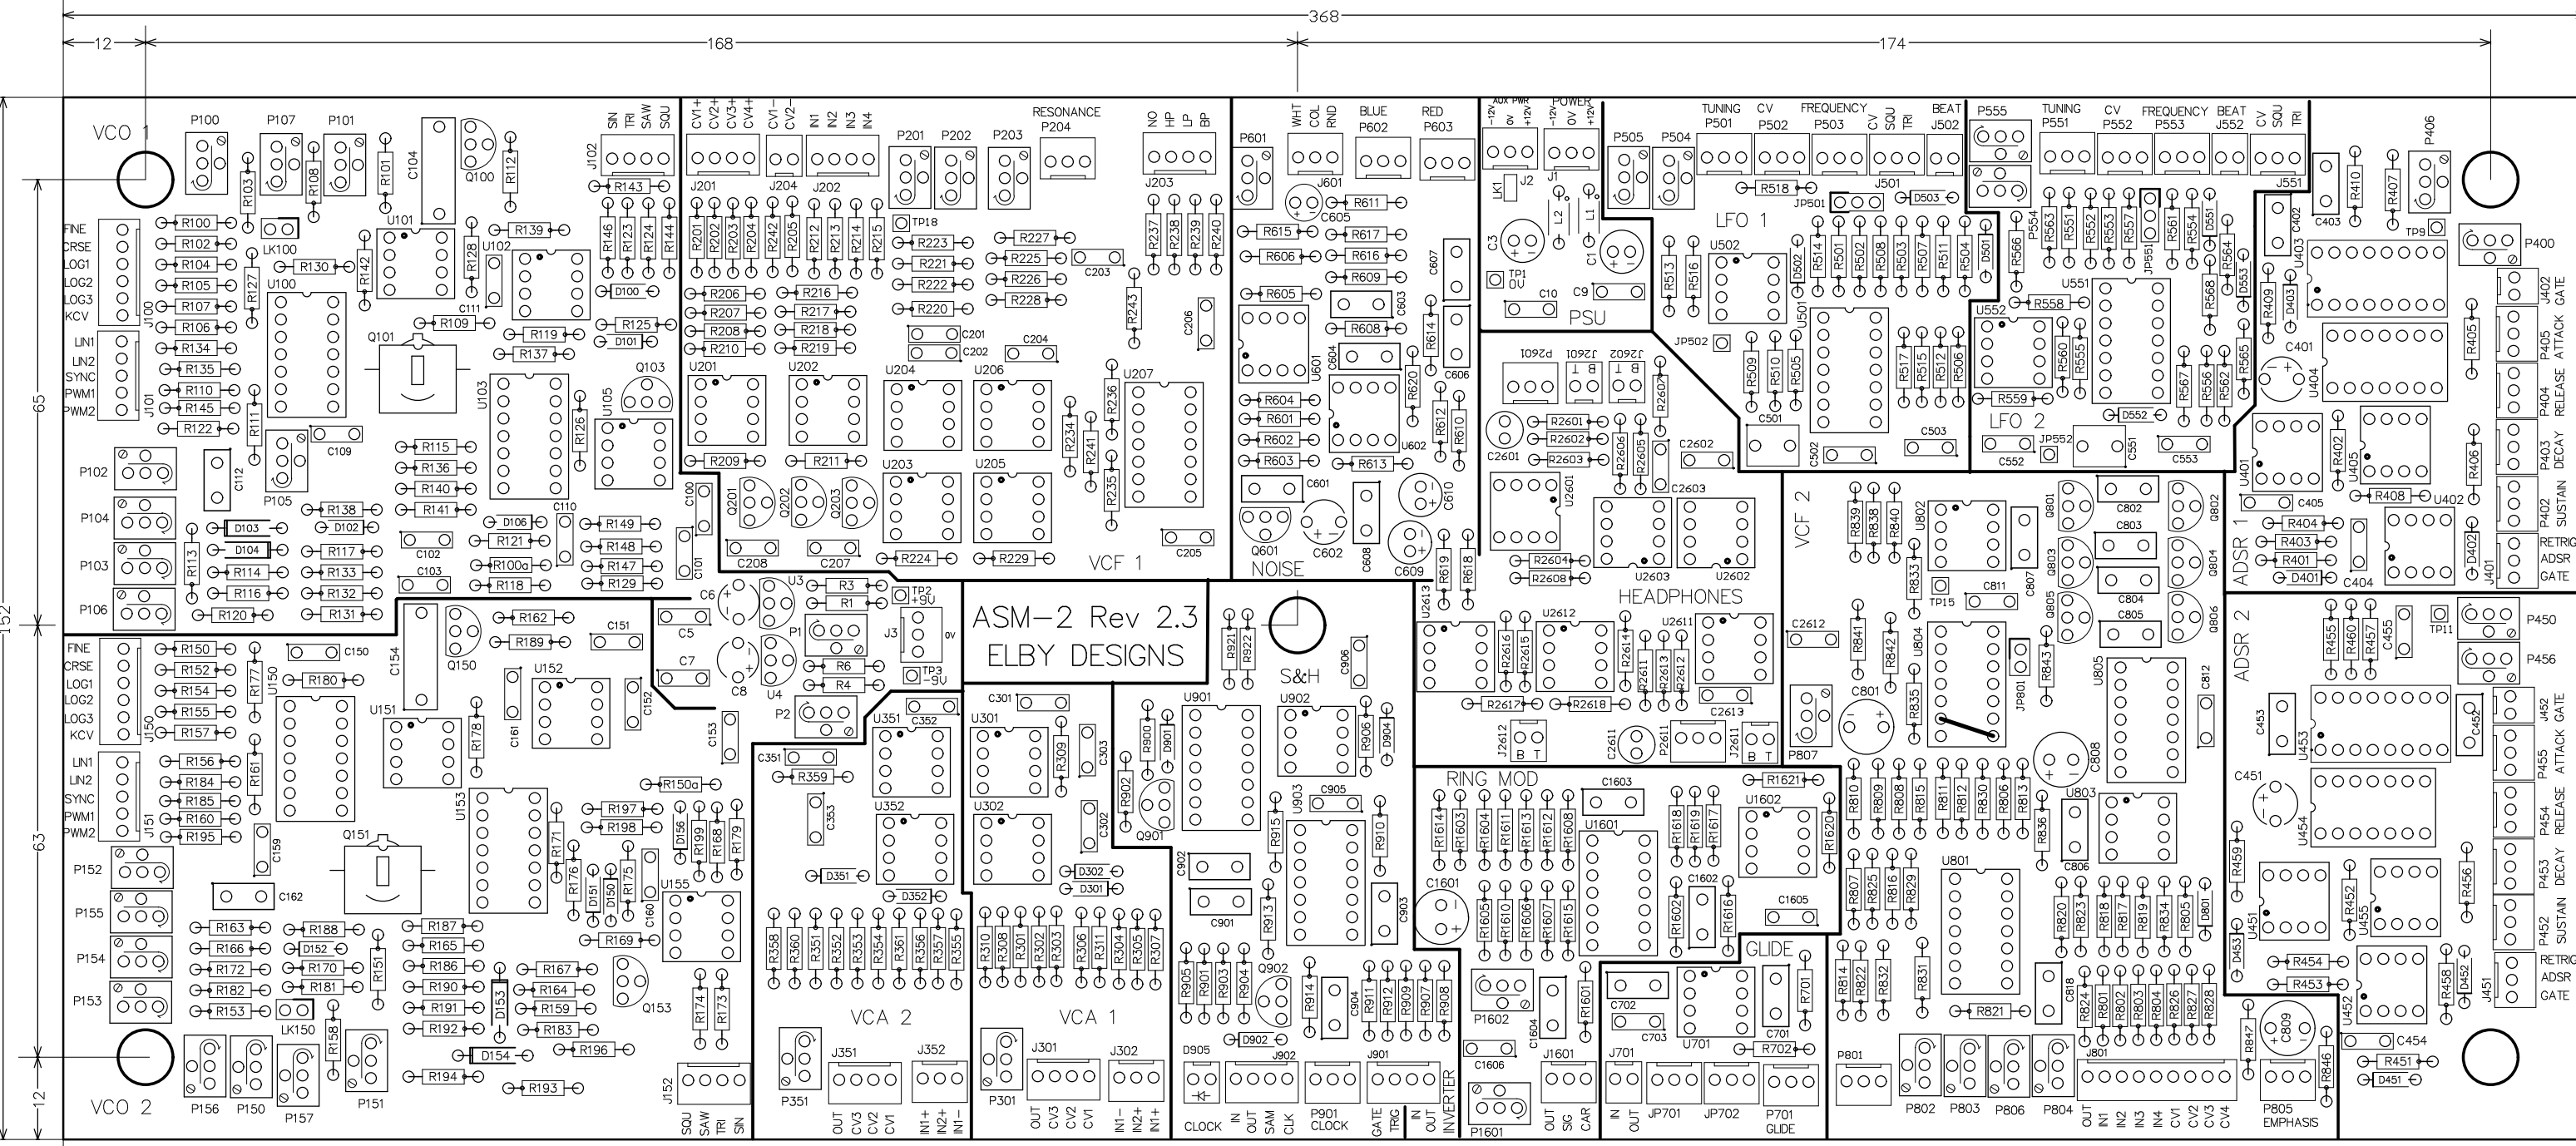
U3 & U4 orientation is incorrect C901 has been replaced with a RESISTOR.
 Stand it on end to fit the footprint

Place Wire Link Between U804_6 & U804_8
